Oxylog 2000
Technical Service Bulletin # 6

Re: **Device mount for vehicles P/N 84 12 069 (Accessory for Oxylog 2000)**

Update: May 22, 2000

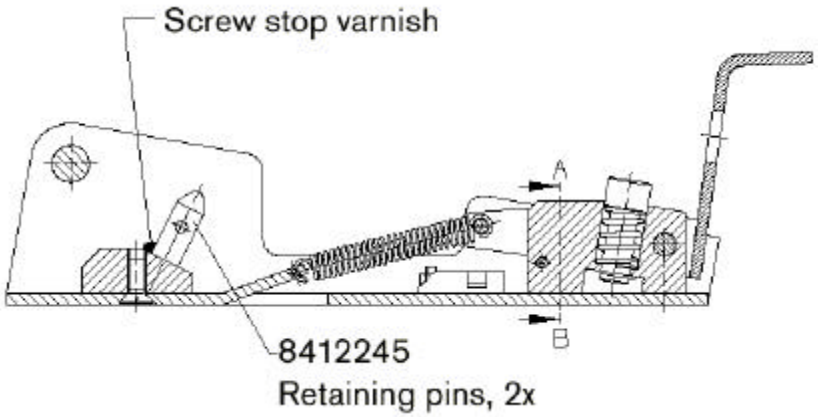
Reason: It has been reported that both retaining pins in the device mount for vehicles P/N 84 12 069 may become loose. If the retaining pins loosen the Oxylog 2000 can fall down in worst case.

Solution: The two retaining pins (P/N 84 12 245) shall be secured with Loctite 221. Mark secured pins with screw stop varnish 3000 ISO red.
